Subject: IWI, Inc. Site  
Federal On-Scene Coordinator's Report, Revision 1

**REVISION 1  
FEDERAL ON-SCENE COORDINATOR'S REPORT  
COMPREHENSIVE ENVIRONMENTAL RESPONSE, COMPENSATION  
AND LIABILITY ACT  
REMOVAL ACTION AT THE  
IWI, INC. SITE  
SUMMIT, COOK COUNTY, ILLINOIS  
SITE ID: B53J  
NPL STATUS: NON-NPL**

**Removal Dates: February 2, 2003, to October 24, 2003**

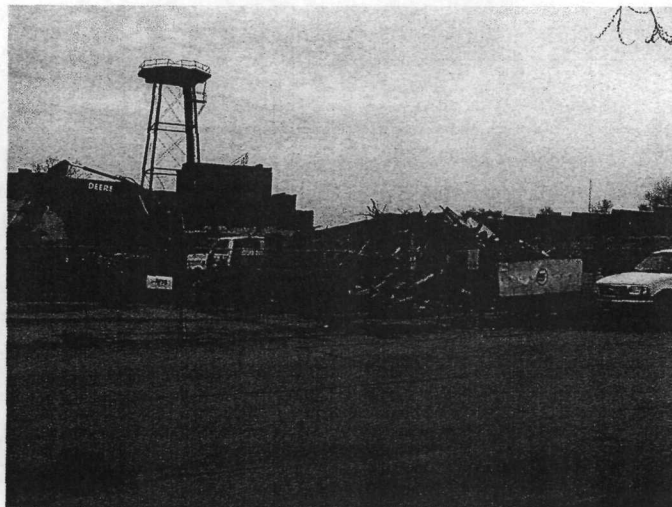
**SUBJECT:** View of site from 61<sup>st</sup> Place; demolition debris in foreground.

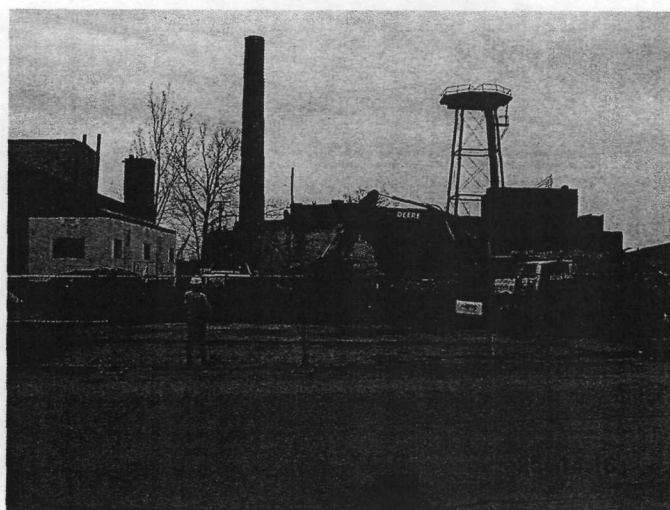
**SUBJECT:** View of site from 61<sup>st</sup> Place; early phase of demolition.

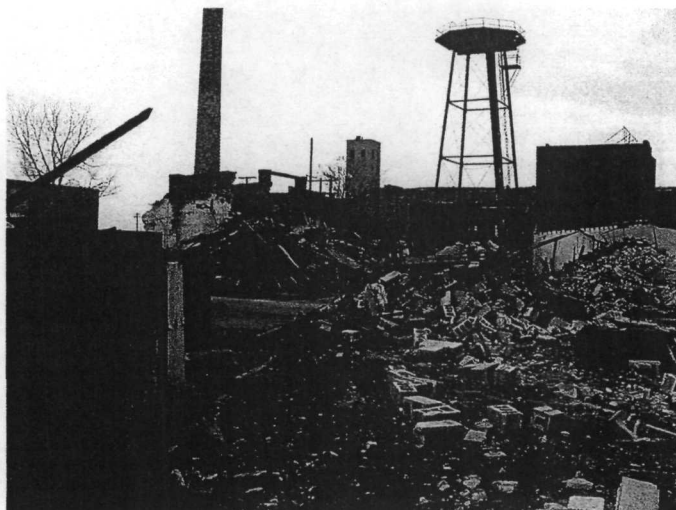
**SUBJECT:** Southeast corner of the site.

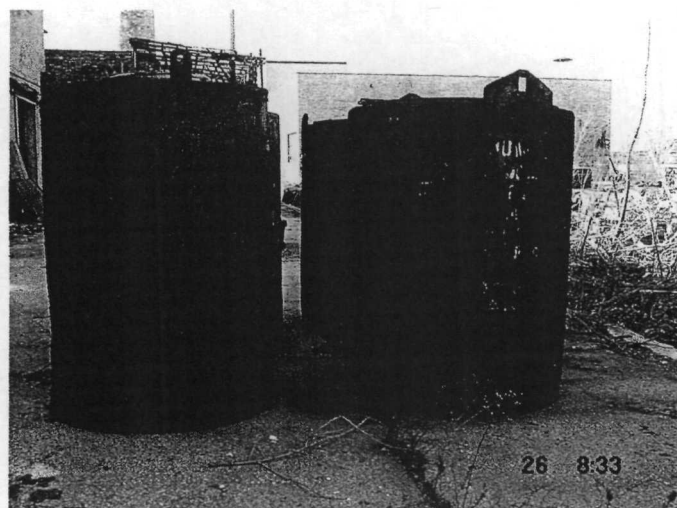
**SUBJECT:** Leaking totes on the concrete apron west of Room 5 of the Main Building.

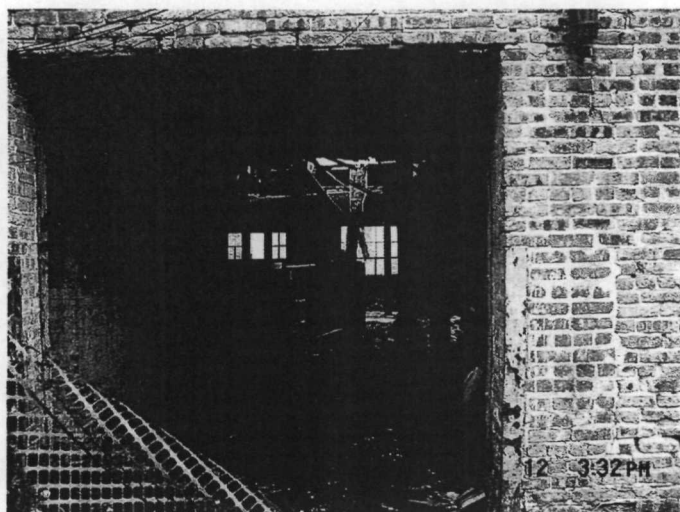
**SUBJECT:** Dilapidated Room 4 of the Main Building; the ceiling is caving in over the chemical totes on the first floor.

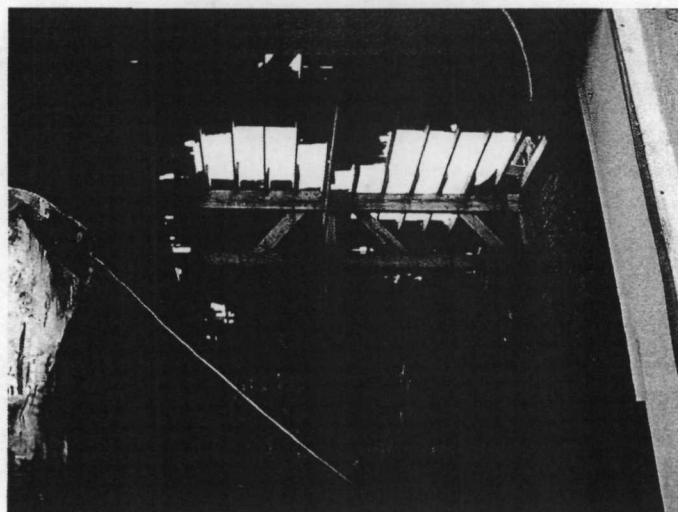
**SUBJECT:** Ceiling caving in at drum storage area, west end of Main Building, Room 5.

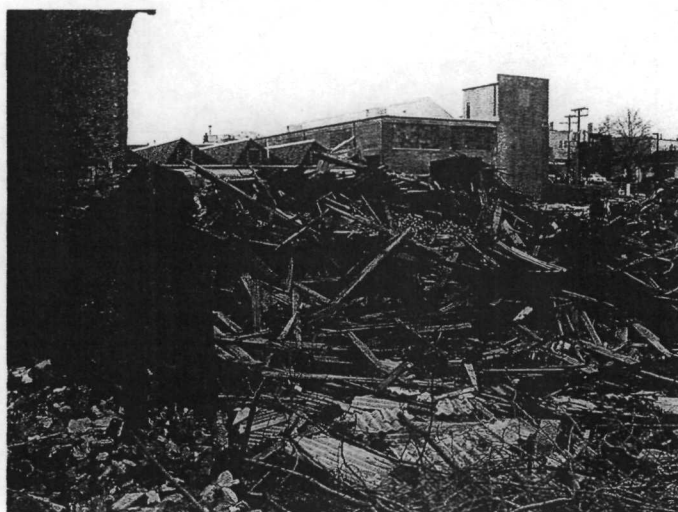
**SUBJECT:** Debris from fire and demolition of office buildings; transite tiles in foreground.

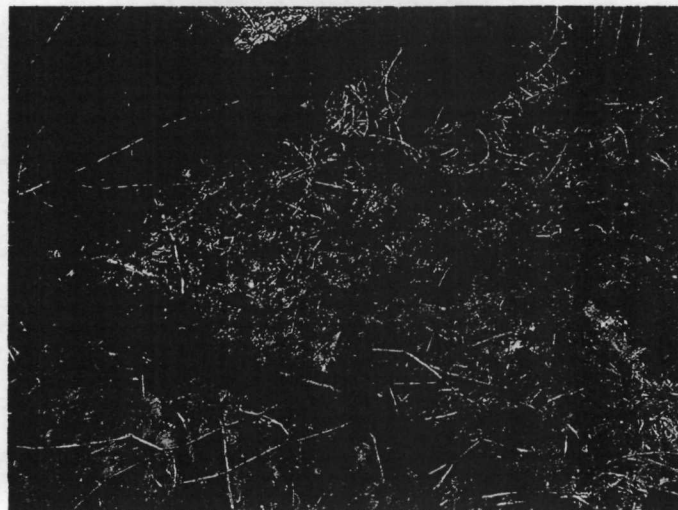
**SUBJECT:** Broken, buried drum in ditch west of Stack Building.

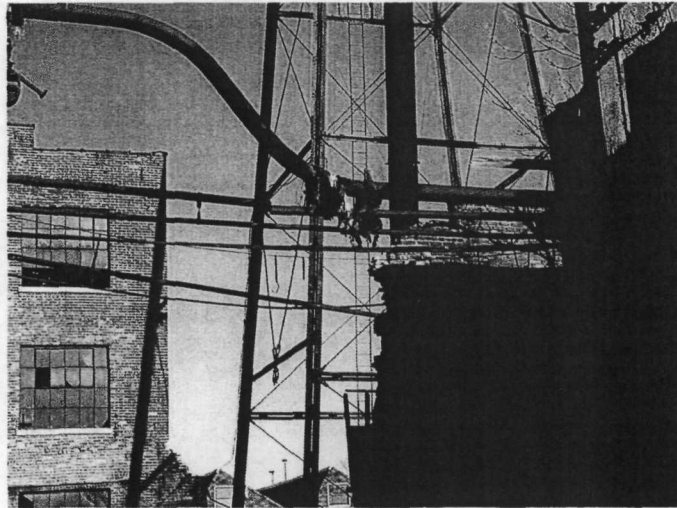
**SUBJECT:** Overhead steam pipe between the Main Building and the Stack Building. Asbestos containing material is located in the pipe-wrap at the center of the photo.

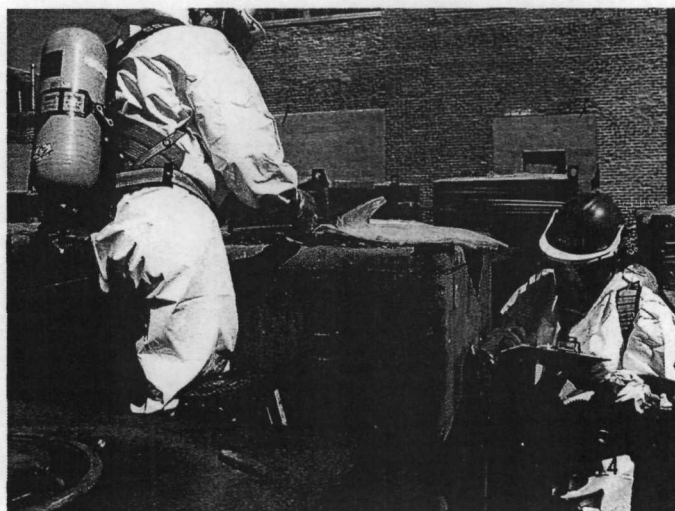
**SUBJECT:** START members sampling chemical totes of unknown contents in Level B personal protective equipment (PPE).

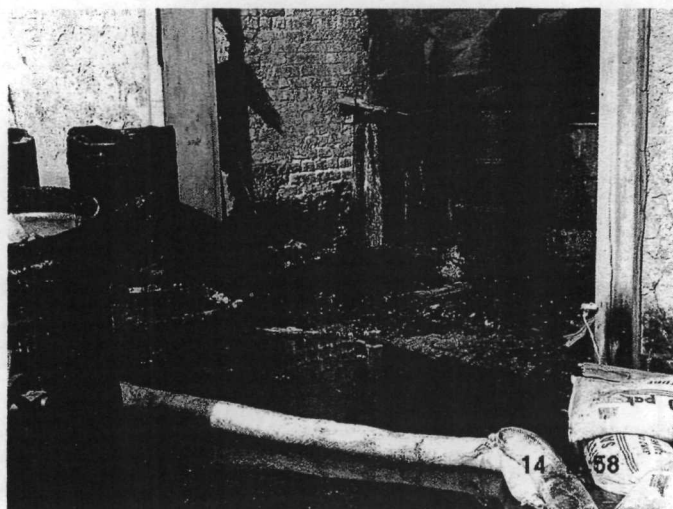
**SUBJECT:** Unknown drum liquid that has leaked from the drum storage room, boom containment in the foreground.

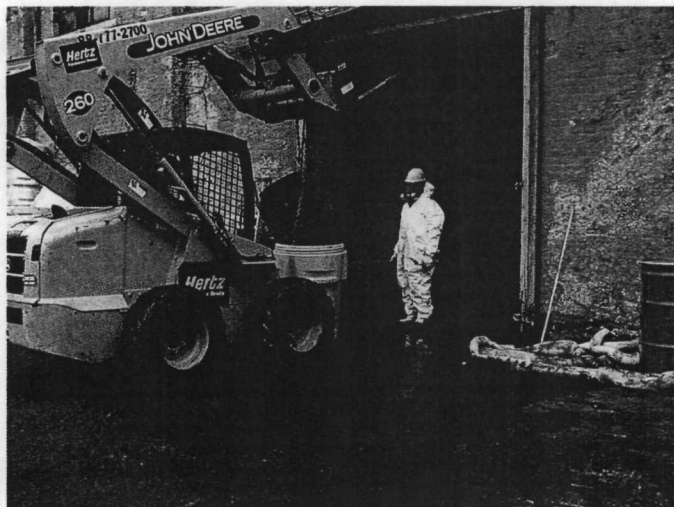
**SUBJECT:** ERRS members loading a corroded drum from drum storage room to a poly overpack.

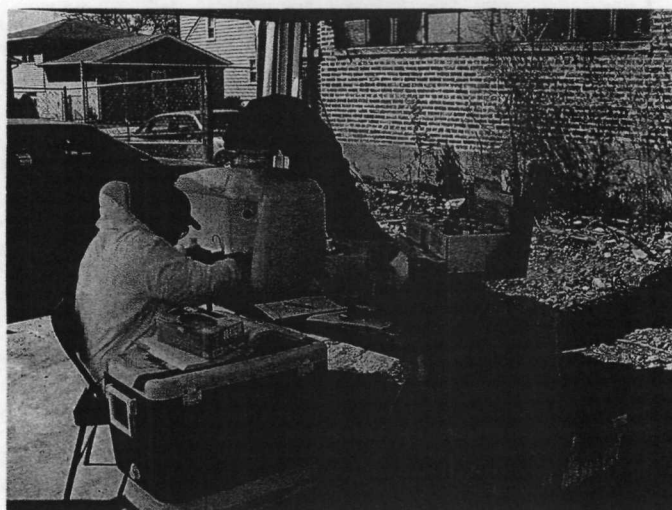
**SUBJECT:** START member performing hazard classification of tote samples in an on-site fume hood.

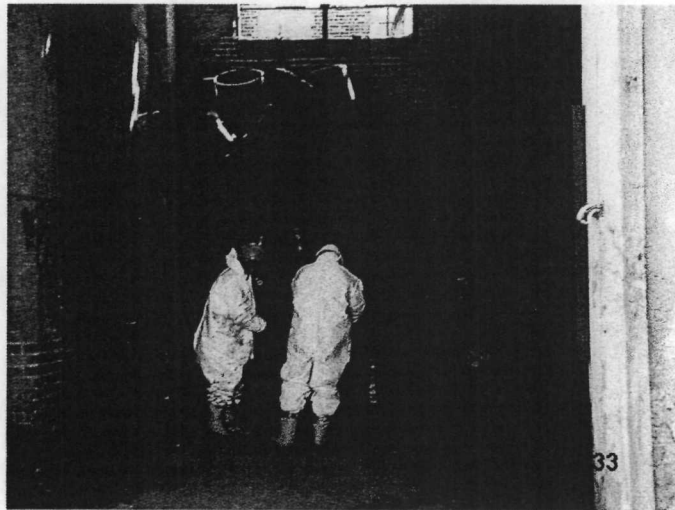
**SUBJECT:** ERRS members inside the drum storage room preparing to remove drums.

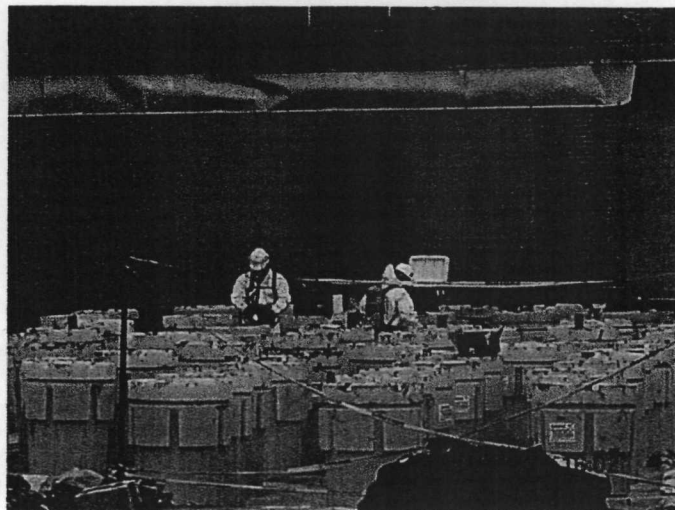
**SUBJECT:** START members sampling overpacked drums with unknown contents using level B PPE.

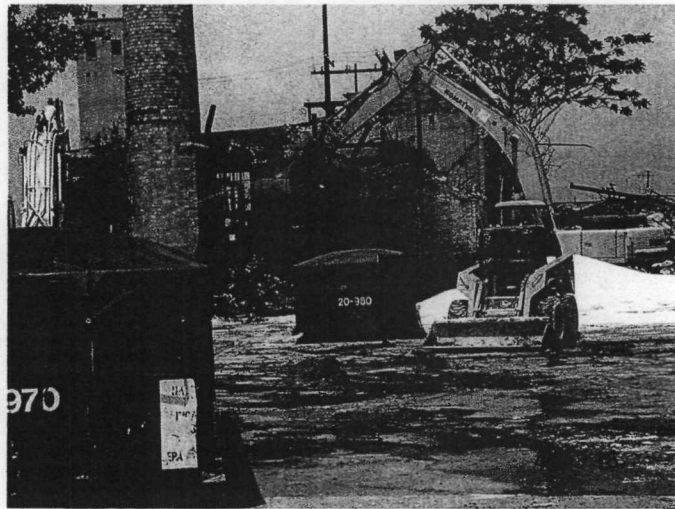
**SUBJECT:** ECC excavator demolishing the north boiler of the Stack Building.

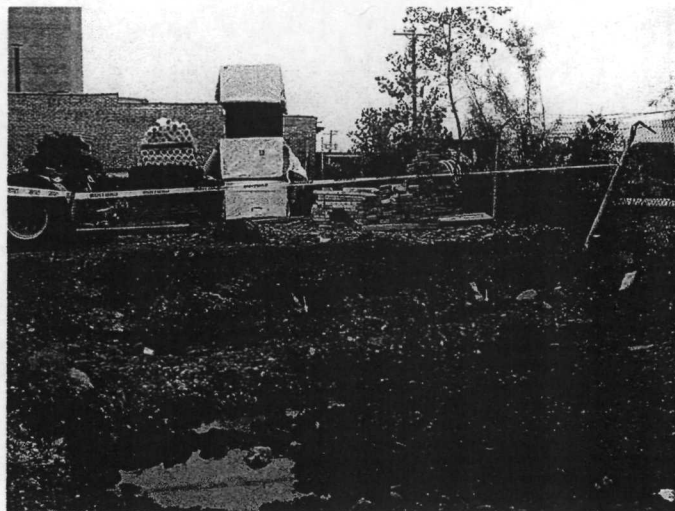
**SUBJECT:** North end of excavation at east end of neighboring yard, to the west of Site (samples IWI-SG-19 and IWI-SG-20).

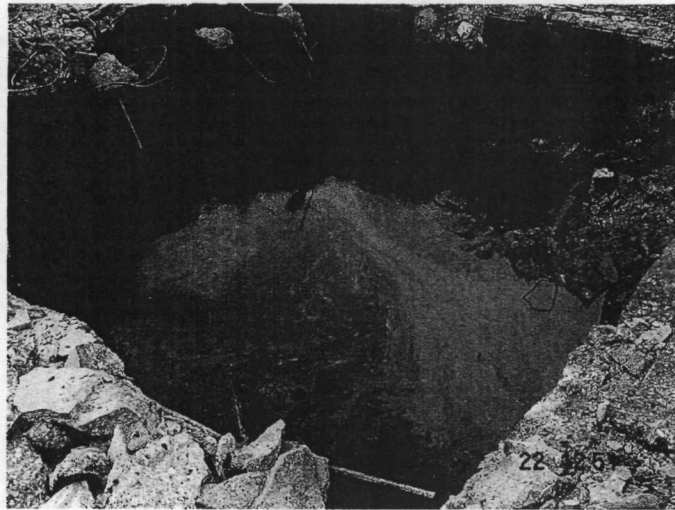
**SUBJECT:** Hole in concrete that reveals the internal structure of Sumps 9 and 10.

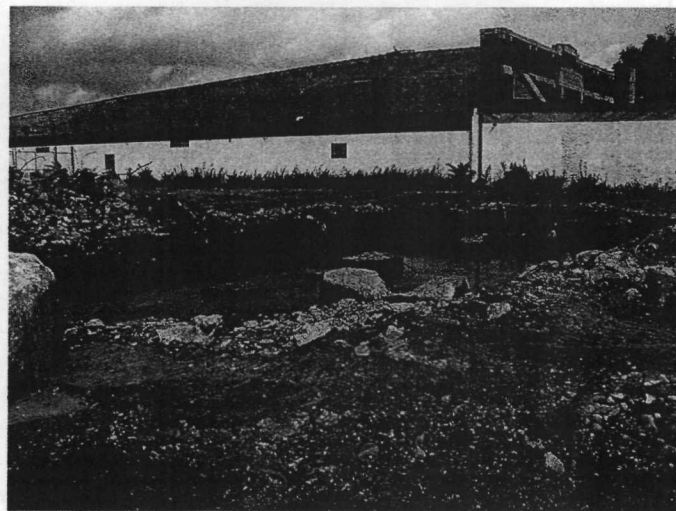
**SUBJECT:** Sumps 9 and 10 with surface concrete removed.

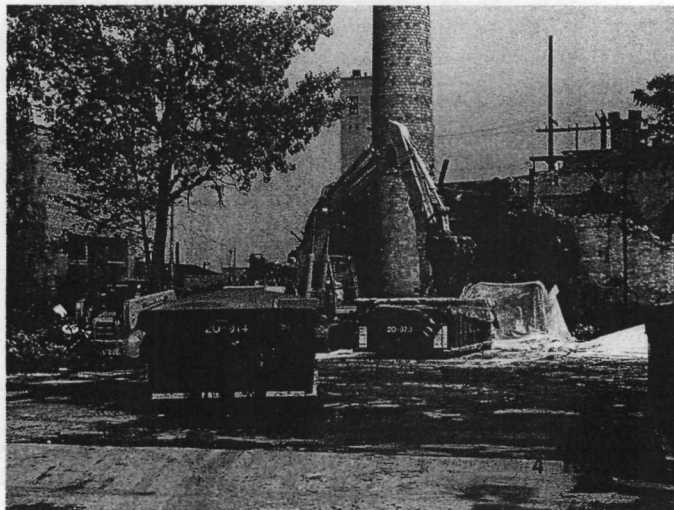
Transportation and disposal (T&D) of the hazardous sludge from the boiler room of the Stack Building took place from July 30 to September 17, 2003. In total, ERRS removed approximately 568 tons of hazardous sludge from the site for disposal at an appropriate T&D facility.

**SUBJECT:** ERRS using excavator to load sludge from the Stack Building into roll-off boxes.
